Manhole Inspection Summary

Manhole # S21U__008MH

Insp Date: **7/1/08 11:36 AM**

Location Address: **1903 western av**

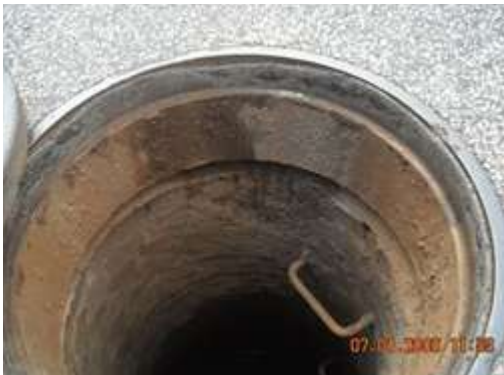
Misc

inflow evidence from sheeting

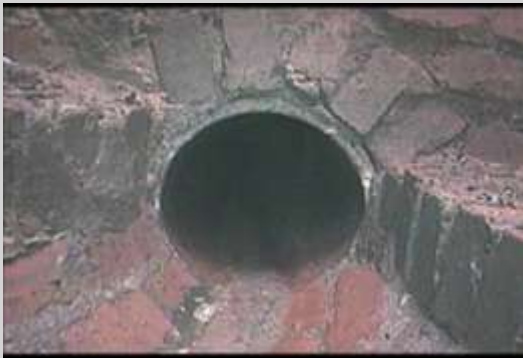
12 O'Clock Outflow

8 in. Circular Gravity Sewer
Pipe Out @ 12 O'Clock

Pipe Height: **8.4** (in.) Rod and Bar (Angled)
Pipe Material: **Clay** ☐ Pipe Lined
Invert Depth: **9.12** (ft.) Flow Characteristics: **Slow**
Deposits: ☒ None ☐ Mud ☐ Sludge ☐ Debris ☐ Grease
Silt Depth: **0** (in.) Deposits Extent:
Infiltration: **None** Pipe Seal Cond: **Sound**

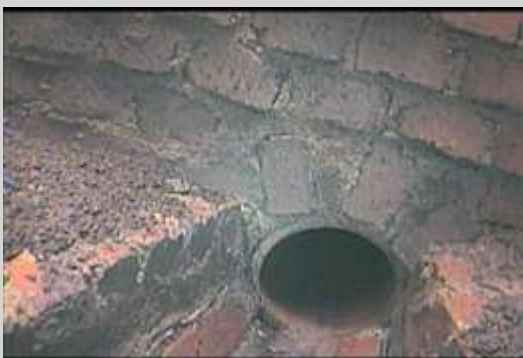
9 O'Clock Inflow

6 in. Circular Gravity Sewer
Pipe In @ 9 O'Clock

Pipe Height: **6** (in.) Rod and Bar (Angled)
Pipe Material: **Clay** ☐ Pipe Lined
Invert Depth: **8.80** (ft.) Flow Characteristics: **Slow**
Deposits: ☒ None ☐ Mud ☐ Sludge ☐ Debris ☐ Grease
Silt Depth: **0** (in.) Deposits Extent:
Infiltration: **None** Pipe Seal Cond: **Sound**
